**BA-1199**

**Masimore Farm House**

**20955 South Ruhl Road**

Inventory No. BA-1199

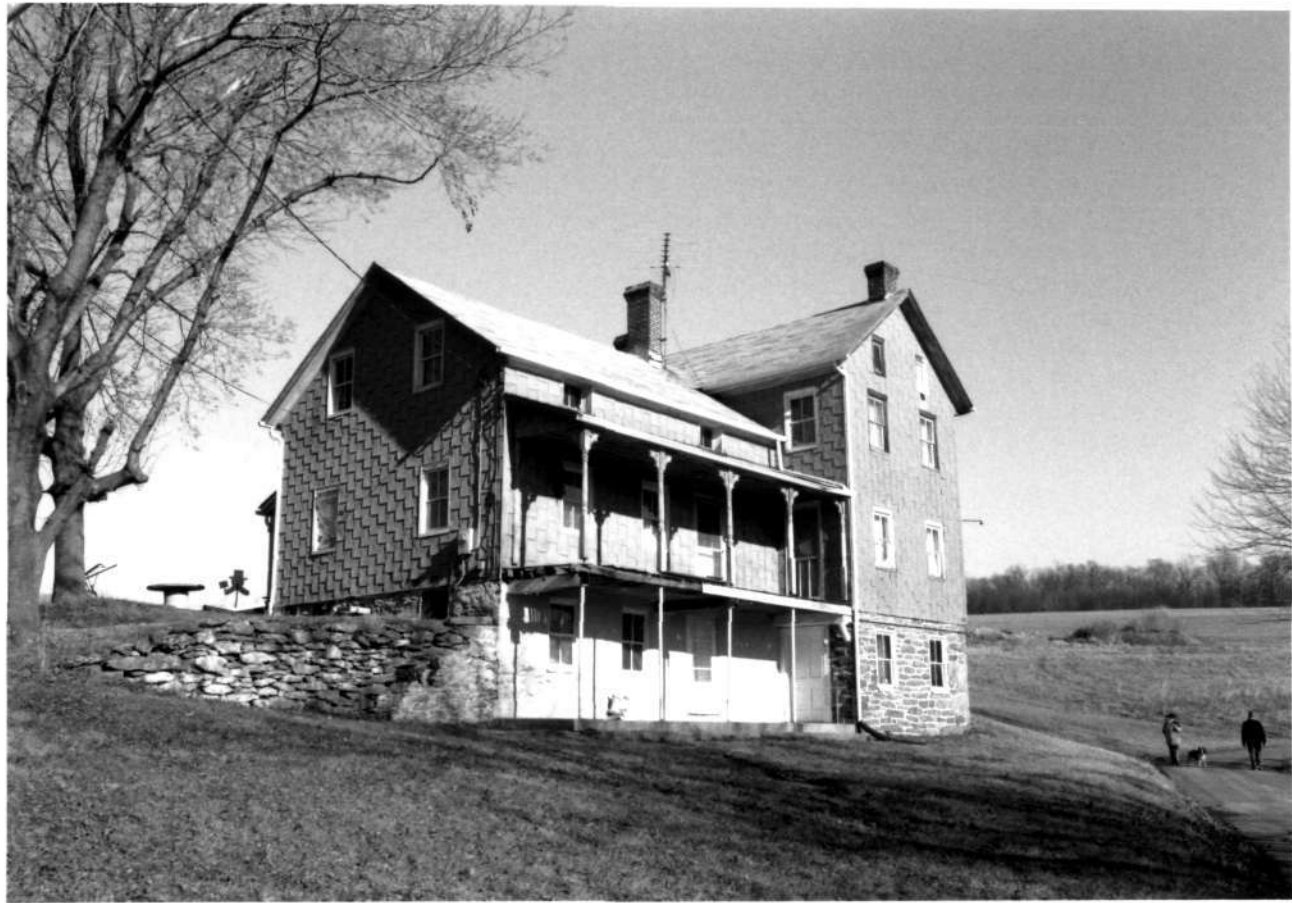
1 of 4

SOUTHWEST CORNER, VIEW LOOKING NORTHEAST

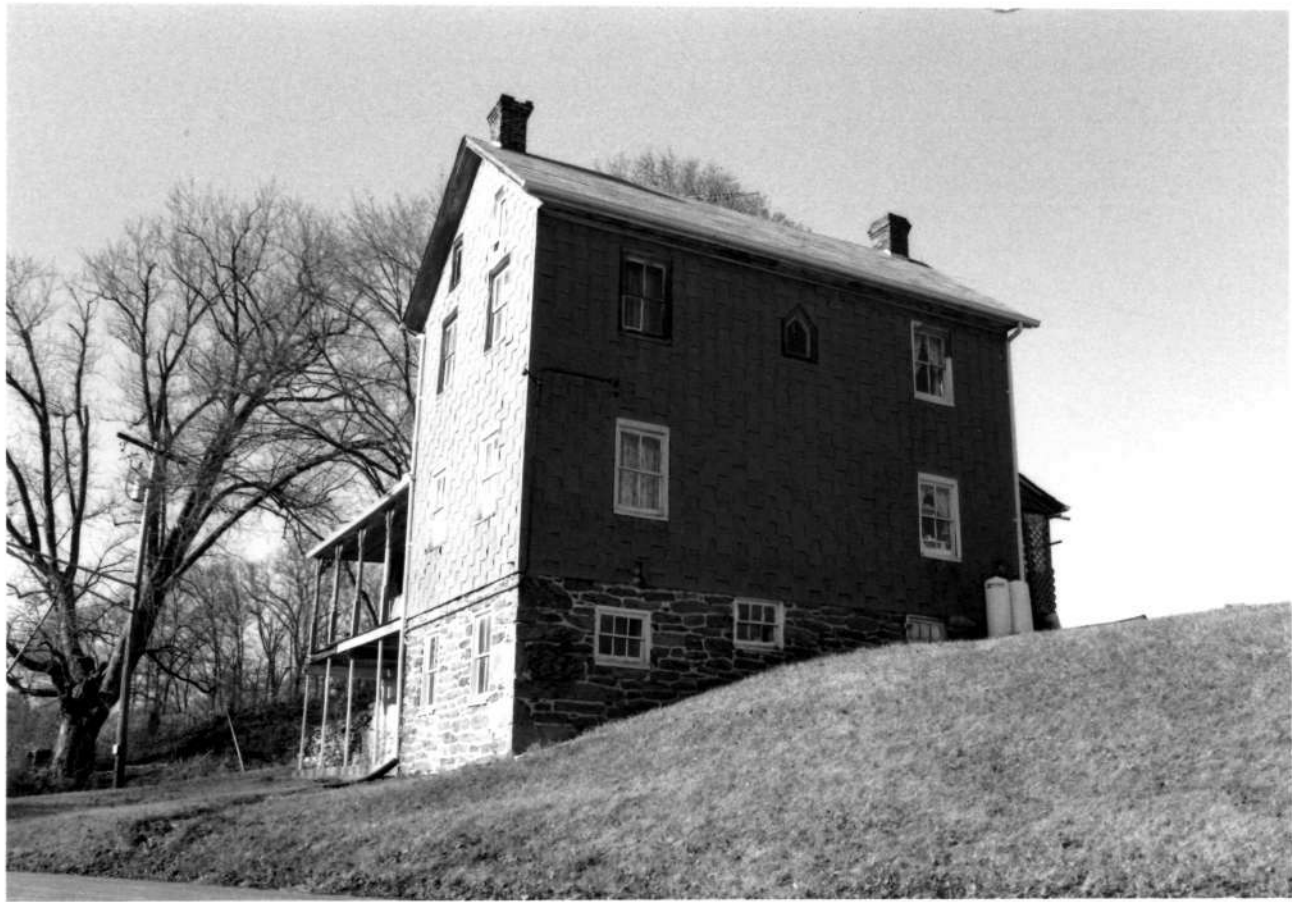
2 of 4

SOUTHEAST CORNER, View looking northwest

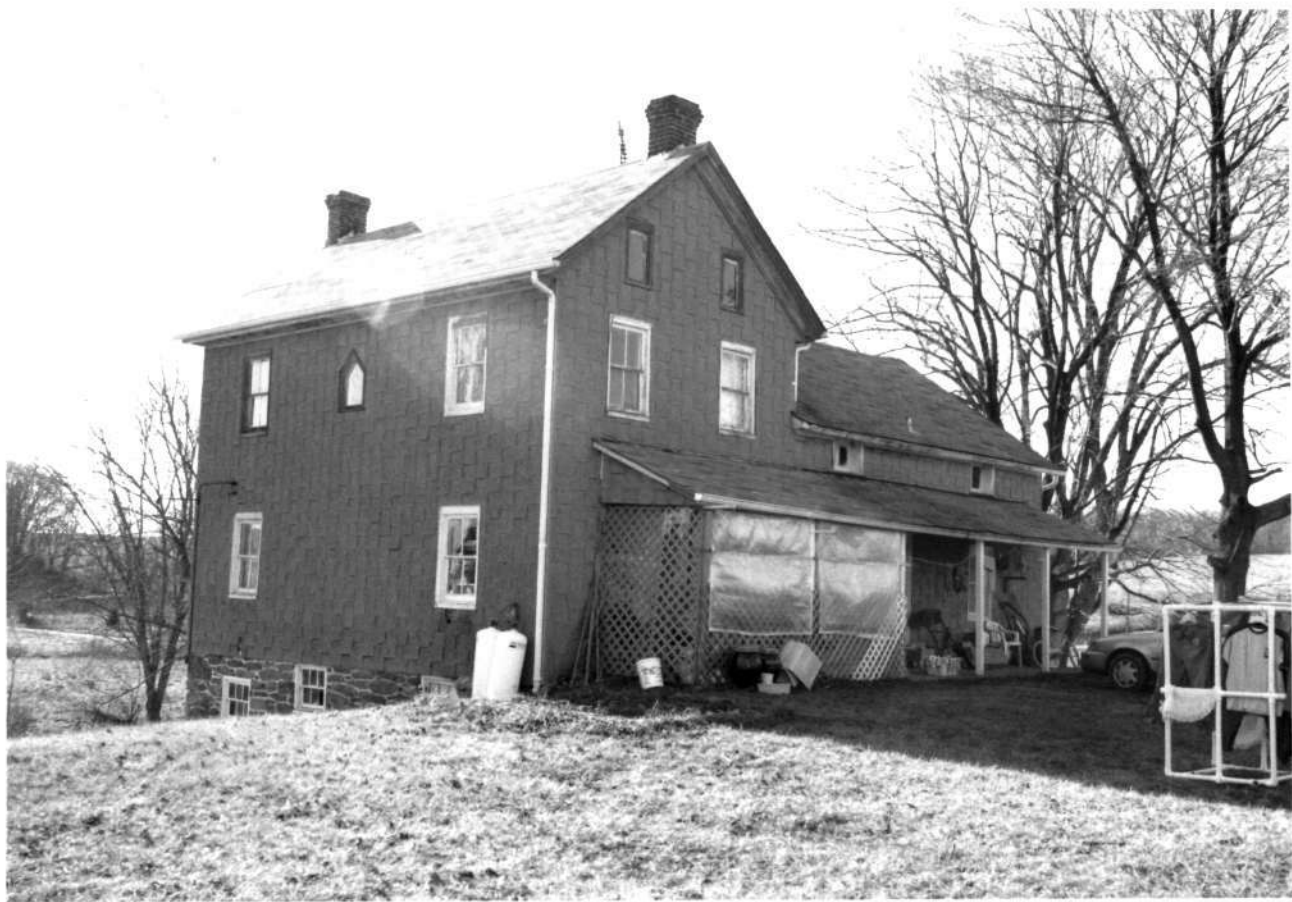
3 of 4

NORTHEAST CORNER

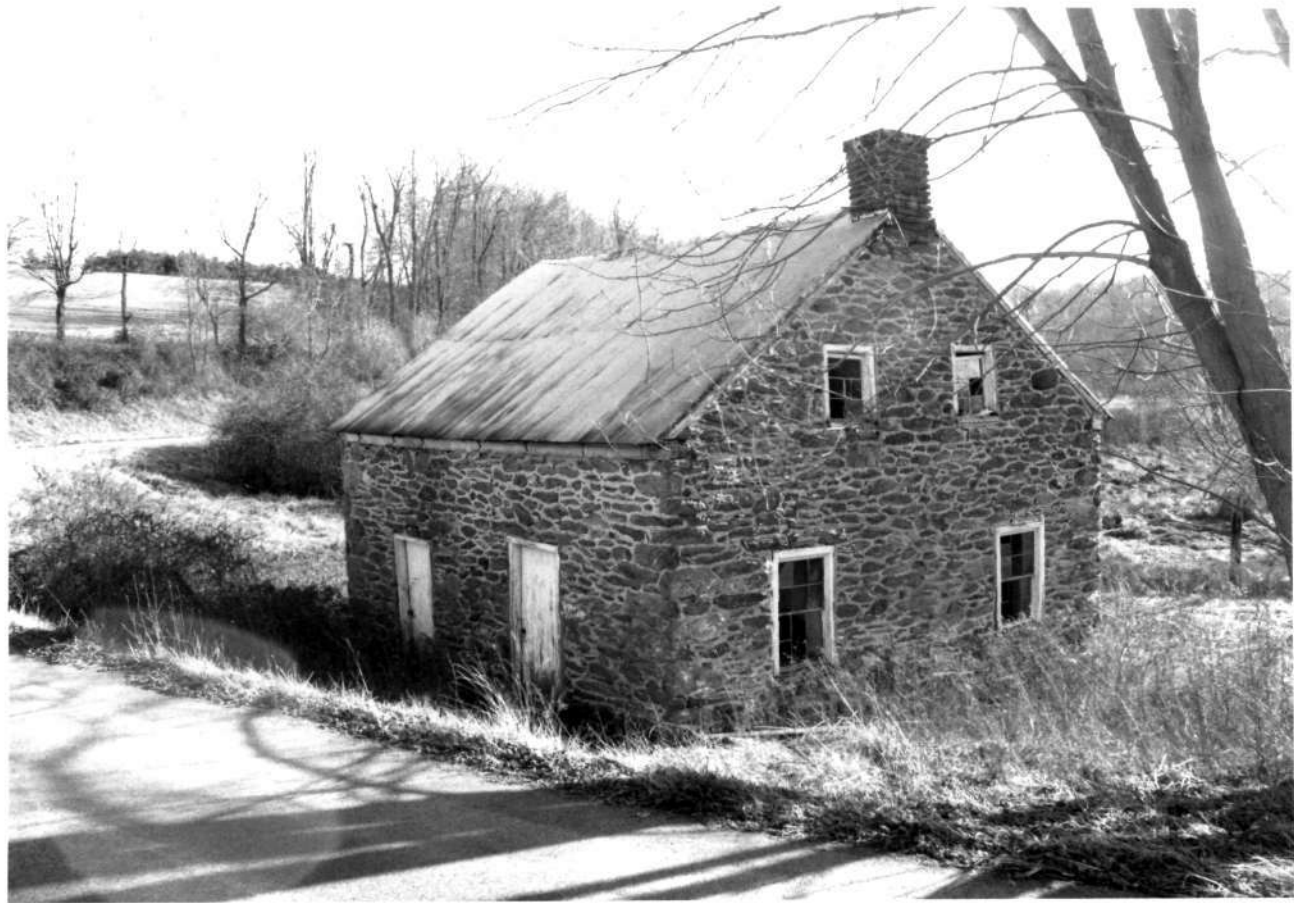
4 of 4

Two historic outbuildings are associated with this property. Across the road facing northwest, is a circa 1880 coursed rubble stone washhouse one-and-a-half stories high. The façade is two bays wide with two single-leaf vertical-board wood doors of varying heights. The house features quoins at each corner. The side elevation is pierced with two 6/6 double-hung wood sash windows and two 6-light wood casement windows. One rebuilt interior-end chimney rises above the side gable corrugated sheet metal roof. The previously surveyed barn has been demolished and replaced with a circa 1990 bank barn. It is one story, clad with corrugated sheet metal, and topped with a front gable roof sheathed with corrugated sheet metal.

WASH HOUSE, NORTHWEST CORNER

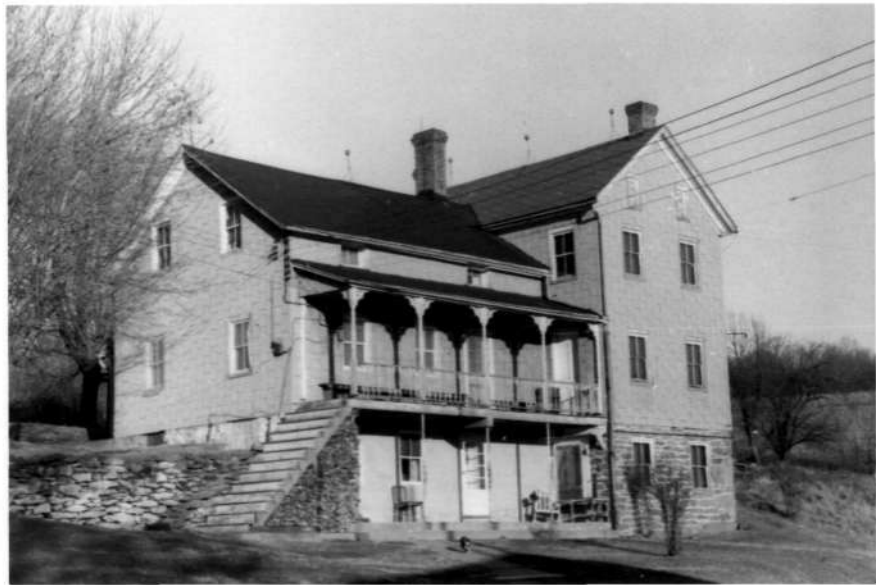
**523E**

This house in two parts is of frame with <sup>gray</sup> asphalt shingle covering clapboard, white trim, over a bank-basement of stone open on the south. T-shaped, a two-story section 3 bays by 2 ~~has a taller two-story~~ faces south, the roof ridge line running east-west while a taller 2 story section, 3 bays by 2, runs across the east end of the house, the roof ridge line running north-south. This taller section added a "bermity" for the many children of Mrs. Masimore's father in about 1900.

VI-NEW-1199 MASIMORE FARM HOUSE  
SOUTH RUHL ROAD, RUHL VICINITY  
view of front (S) elevation, looking NE  
PHOTO: JEAN S. EWING (MHT) 1/73 (frame 20A)

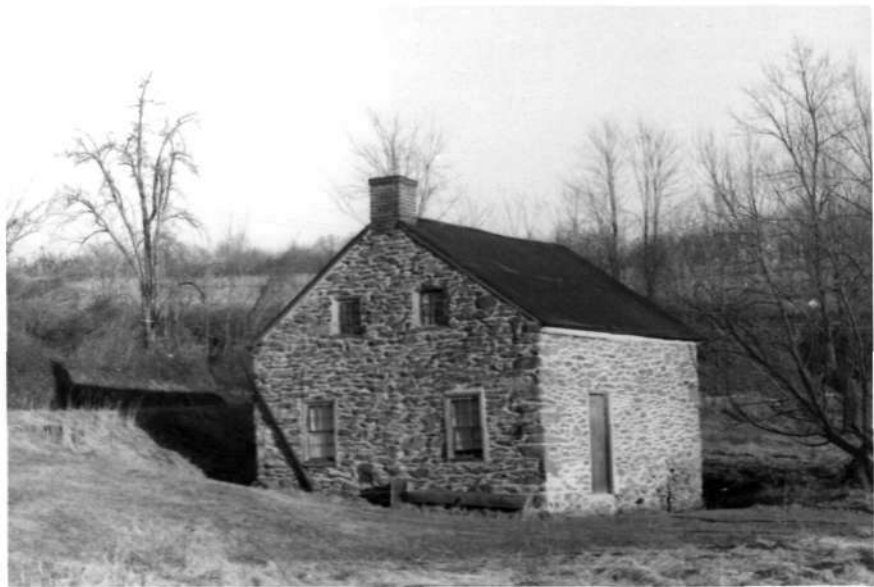
523E

- (A) There is a stone wash house across the road, 1½ stories, about 15' x 18'. A single door faces south. 2 windows are in each end wall facing east and west, 6/6, and 2 windows upstairs west, 3/6. (See photo)

VII-NEW-1199A MASIMORE FARM, WASH HOUSE  
SOUTH RUHL ROAD, RUHL VICINITY
